Avalanche

SNOW AVALANCHE

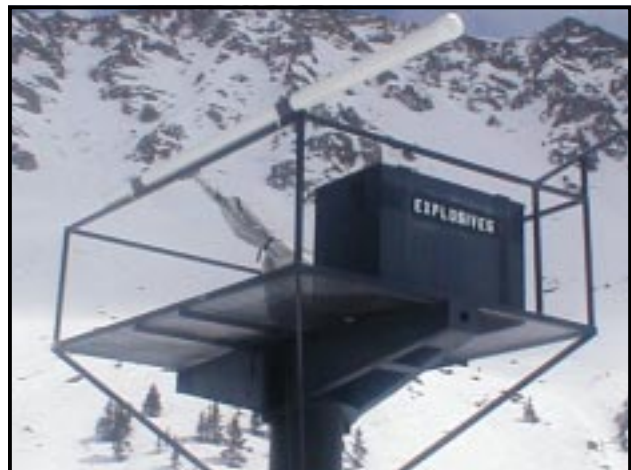
Avalanche mitigation at Arapahoe Basin along Highway 6 just north of Loveland Pass
Photo by CDEM

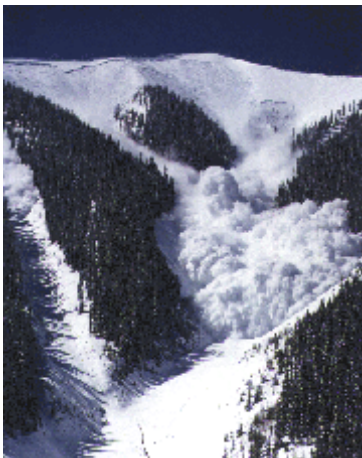
The Battleship (also known as Arnold) is a large path along US 550 in southwestern Colorado. It is located in the San Juan Mountains about 3.55 miles north of Silverton. The top of the starting zone is at 12,400 feet, and avalanches can fall 2720 feet to Mineral Creek, but very large slab avalanches such as this one can climb the 250 feet from the creek to the highway. This avalanche buried US 550 3 feet X 800 feet on February 28, 1987, Red Mountain Pass, Colorado. Photo by Tim Lane.

Avalanche paths consist of a starting zone, a track, and a runout zone. In general the runout zone is the critical area for land use decisions because of its otherwise attractive setting for development. Avalanche-prone lands may pass many winters or even decades without a serious avalanche. Only part of an avalanche may release at once. Lack of vegetation or a predominance of quick-growing aspen and low shrubs often characterize active portions of an avalanche track and the runout zone, readily identifying the seasonal peril. Hundreds of snow avalanches happen each winter, most of them in remote places.

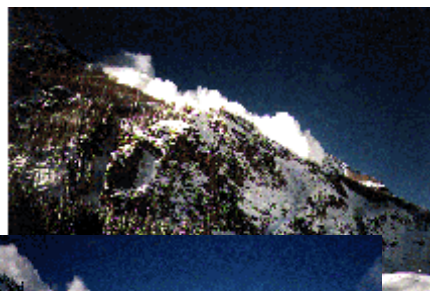
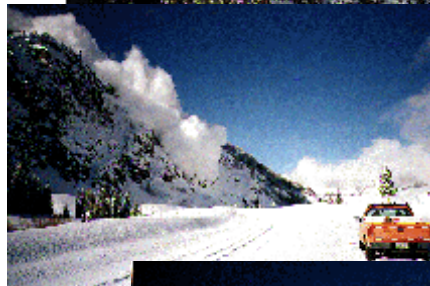
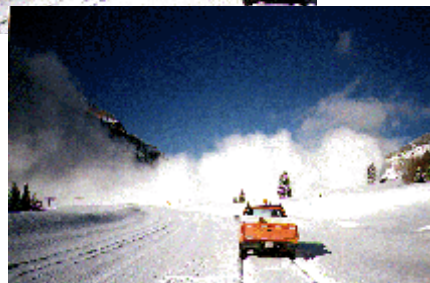
West
Riverside,
Red
Mountain
Pass,
Colorado.
Photos by
Don
Bachman.

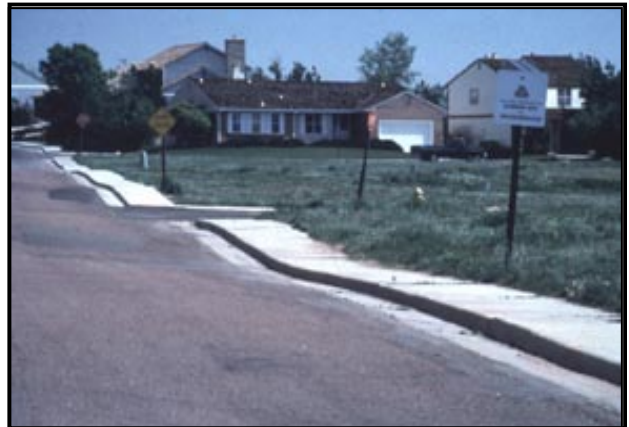
The "roller-coaster road" is the result of uneven swelling and heaving of steeply dipping bedrock layers. Photo by Dave Noe, Colorado Geological Survey

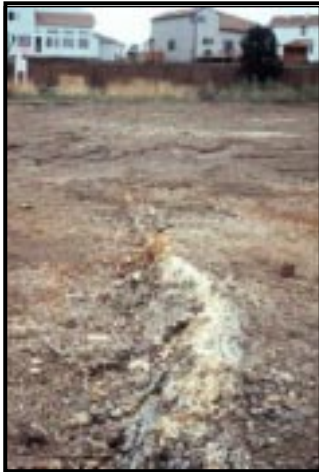
A near-vertical bentonite layer in the Upper Cretaceous Pierre Shale in Jefferson County.
Photo by Dave Noe, Colorado Geological Survey

As seen in the photo below, the bentonite layer heaved approximately three inches within 24 hours after a rainstorm at this construction site. There is also a hump in the fence aligned with the trend of the bentonite layer. Damage is occurring in the subdivision in the background.

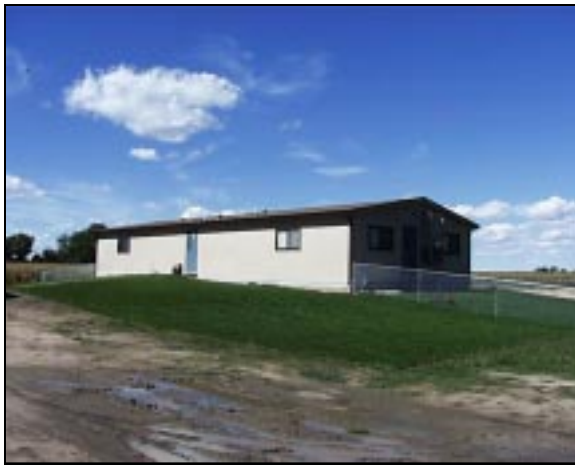
Building elevated in Morgan County
Photo by CDEM

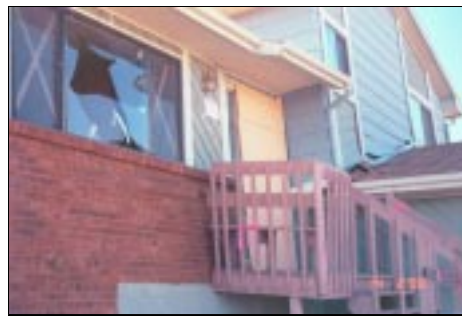
Home Destroyed by Landslide in Colorado Springs
Photo provided by Colorado Springs Emergency Management

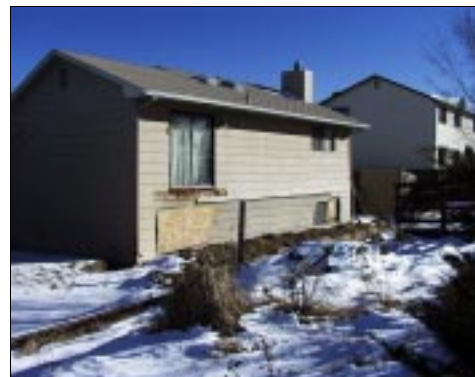
Landslide Damage to Home in Colorado Springs
Photo provided by Colorado Springs Emergency Mgmt

The following photograph demonstrates the serious nature of these hazards in Colorado. The structural integrity of this home was destroyed. The home was condemned and has been demolished.

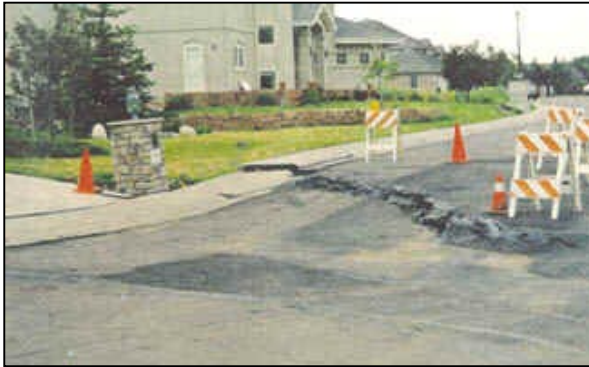
Scarp of the Green Mountain Landslide
Photo by Colorado Geological Survey

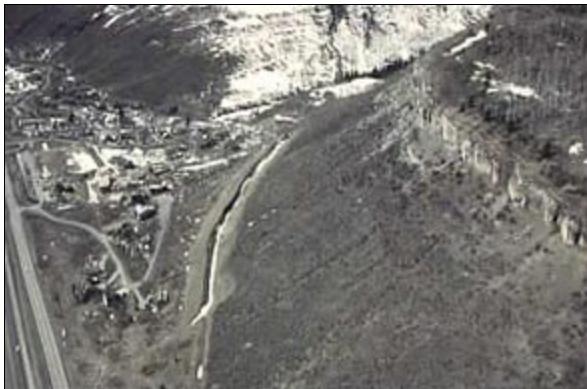
The area and damage of the Booth Creek Rockfall of March 1997. The town of Vail is below the cliffs above Booth Creek. The cliff is the origin of the boulder that damaged houses in the town below.

Rockfalls can demolish structures and kill people. Rocks falling on highways may strike vehicles, block traffic, cause accidents, and sometimes damage the road. Minor but costly consequences is the work of clearing highways and borrow ditches in rockfall areas. Any structure in the path of a large rockfall is subject to damage or destruction.

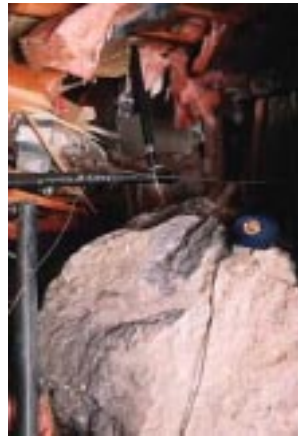
The image shows the damage created by the falling boulder in the Booth Creek Rockfall. Photo by Jon White, Colorado Geological Survey.

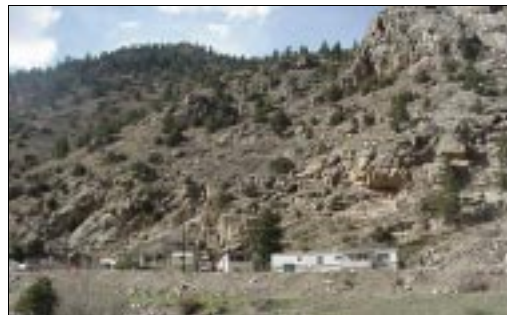
Rockfall Area Along I-70 Corridor Near Lawson, CO
Photo by David C. Marlin
